WELL EQUIPMENT RECOVERY

CLIENT: Arizona mining client TECHNOLOGIES: Rotary drilling

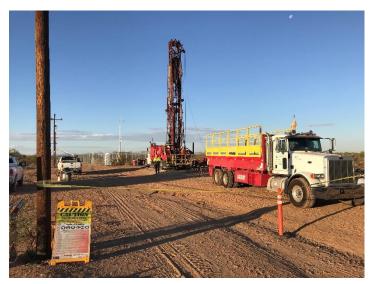
Drill site setup with 50K drill and support truck

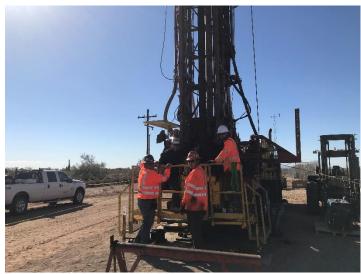
Crew having a safety discussion on the work platform of the drill
